BS EN 13823:2010+A1:2014

Reaction to Fire Tests for Building Products - Building Products Excluding Floorings Exposed to the Thermal Attack by a Single Burning Item

A Report To: DSC Co., Ltd

Document Reference: 421665

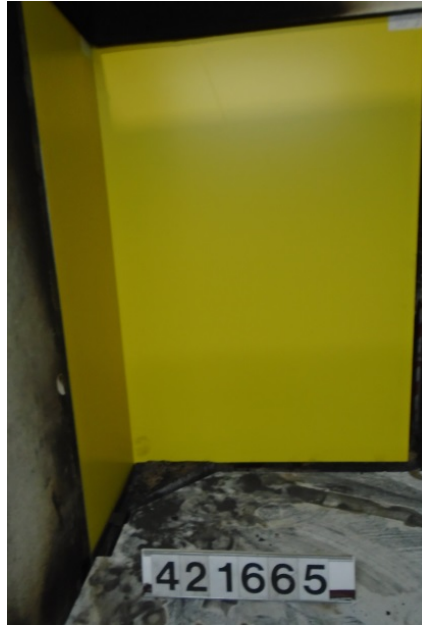
Plate 1: Total View of the exposed surface of the long wing.

Photographs of the installed product are appended as Plates 1 and 2 in Appendix 1 of this report.

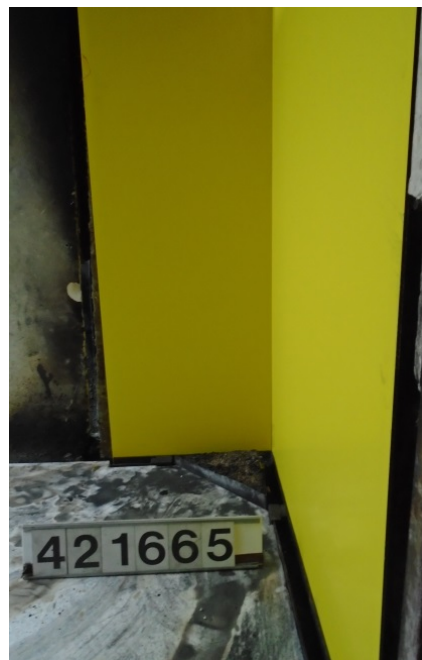
Plate 2: Close up view of the vertical outer edge of the long wing at a height of 500mm
